OGMCOAL - Wellington Prep Plant 2nd Quarter 2009 Water Quality Report

WATER QUALITY M E M O R A N D U M

RE: 2009 Second Quarter Water Monitoring, Nevada Electric Investment Corporation, Wellington Preparation Plant, C/007/0012, Task ID #3315

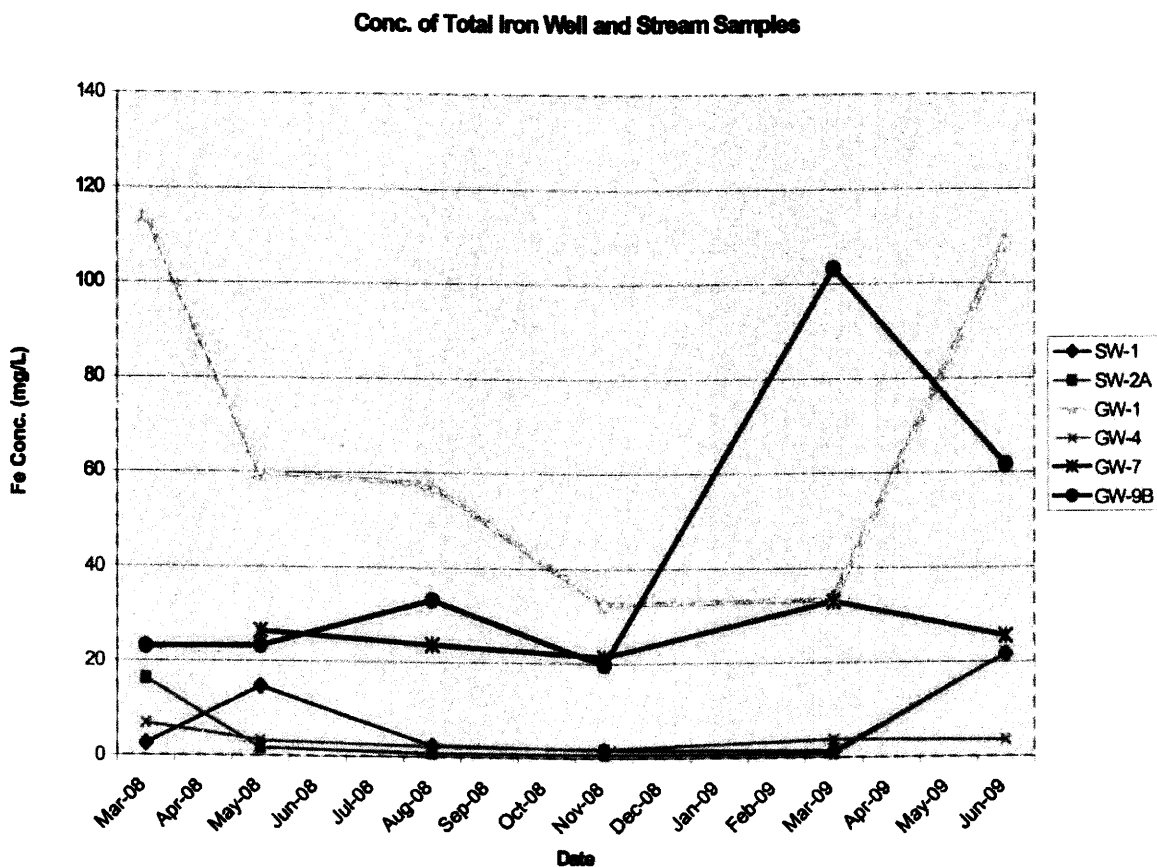
In SW-1, the Price River sample collected above the Prep Plant, total suspended solids (TSS) was elevated in both surface water samples SW-1 and SW-2A detected at concentrations of 1,810 parts per million (ppm) and 1,914 ppm, respectively. Total Dissolved Solids (TDS) concentrations in the surface water samples were much lower than the previous quarter's concentrations. Additionally, oil and grease was not detected in SW-1 this quarter, whereas a concentration of 6 ppm was detected in this sample during the previous quarter. Total iron concentrations were higher than normal in the surface water samples during this quarter (refer to Chart 1).

Total iron concentrations were lower in some of the groundwater samples from last quarter but spiked in GW-1. All other parameters appeared to be within their historical normal ranges. Chart 1 shows the total iron concentrations during the June 2009 sampling event for all select monitoring wells.

- Total iron levels appear to be elevated in most of the groundwater monitoring wells at the site. Total iron concentrations for most of the wells were in line with previous results for each respective well. Surface water samples were also slightly elevated. Surface water samples collected during the second quarter and select groundwater samples are shown on Chart 1.
